REPAIR OF HAIL/WIND DAMAGE

## Recommendations for Repair of SPF (Spray Polyurethane Foam) Roof Systems Due to Hail and Wind Driven Damage

SPFA-139

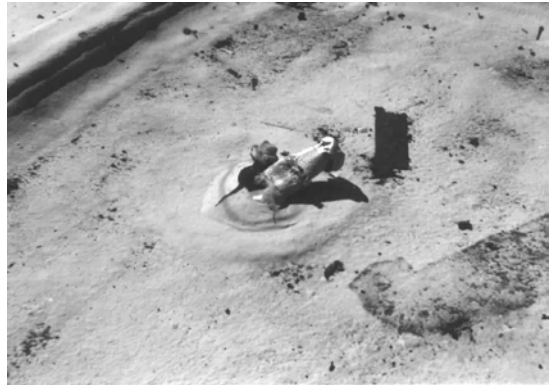
### (1) Mechanical damage due to wind driven missiles

During high-wind events, a wide variety of objects can potentially impact a roof and produce damage to the protective coating and SPF. This damage may be isolated to small areas of the roof or cover large areas. Substrate and structural damage may or may not have occurred and should be thoroughly investigated. The type of repairs required will depend on the size and severity of the damage, and should be consistent with SPFA Guideline SPFA-122, "The Renewal of Spray Polyurethane Foam and Coating Roof Systems."

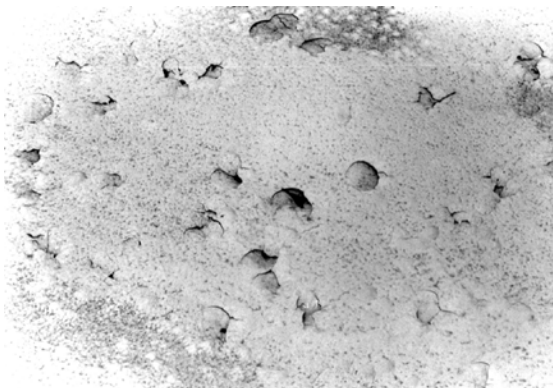
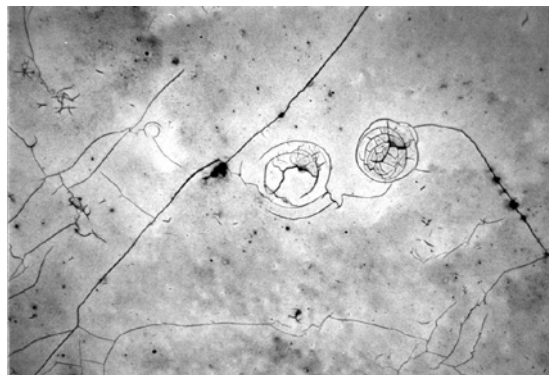
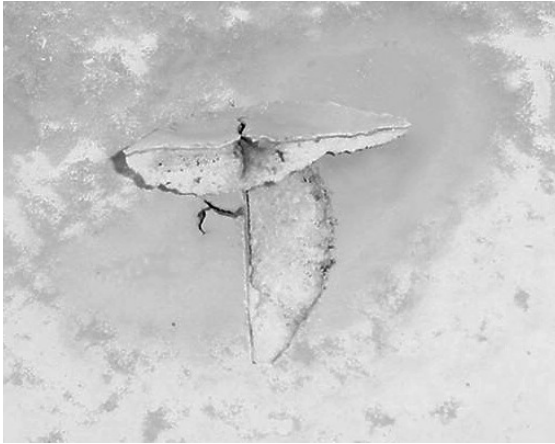
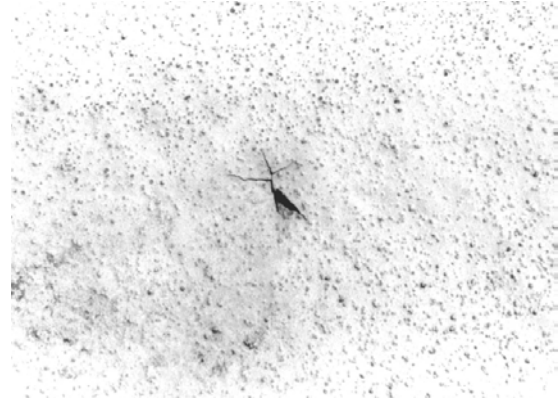
### (2) Hail

Hail can damage both the surface coating and the underlying foam in an SPF roof system.

Coating damage can appear as gouges, cracks, and punctures. Hail-induced coating cracks often form patterns shaped like “crow’s feet” or semicircles.

Depending on the hailstone size, shape, and hardness, the underlying foam may be dented, cracked, or gouged. Depressions in SPF dented by hailstones may be 1/8 inch to 3/4 inch deep. Hail damage can be isolated to small areas or can cover the entire roof surface.

The repair technique is determined from the severity (size and depth of damage) and extent (number of hail hits per unit area) of the hail damage. For example, fifteen 3-inch diameter hail dents on a 1,000 square foot roof may be easier to repair than hundreds of 3/4-inch-diameter dents.
